Porsche patina: Rejuvenating a 928

By Pablo Deferrari

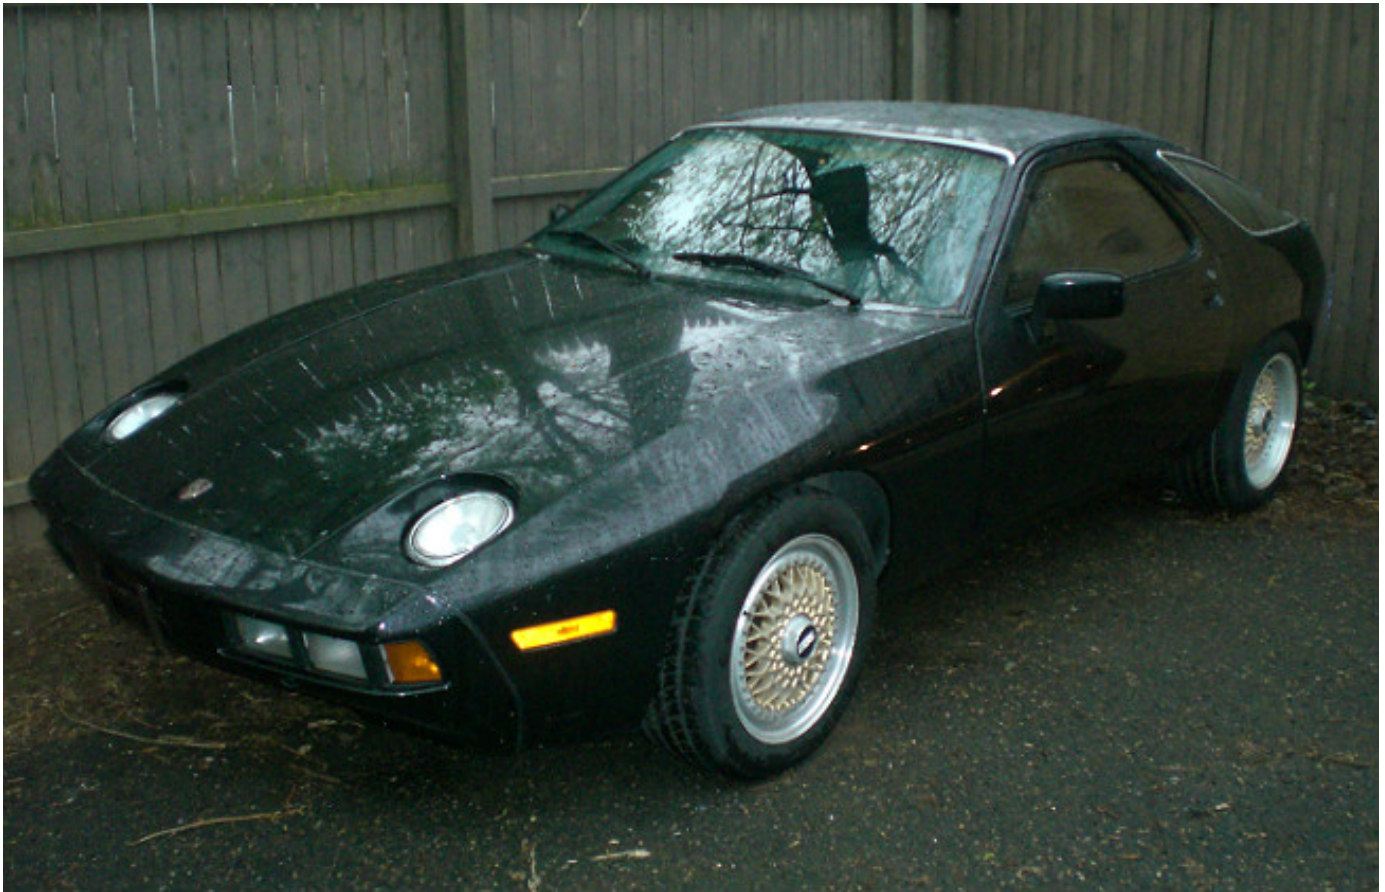
She was finally home, our new 1979 Porsche 928 #1887.

It had just about everything wrong with it: poor paint with some oxidation; a botched attempt at fixing the roof's rust in what resembled spackle painted over with a can of Krylon; a dash and steering wheel devoid of its leather; leaking radiator and gas tank; headlights that didn't pop up; missing rear passenger side seat; sagging front seats; oh, and it wouldn't stay running for more than two minutes. I should have walked away, but I threw out a ridiculously low number and not only was it accepted, the towing to our house was thrown in. I figured I had a 10-horse lead on this one.

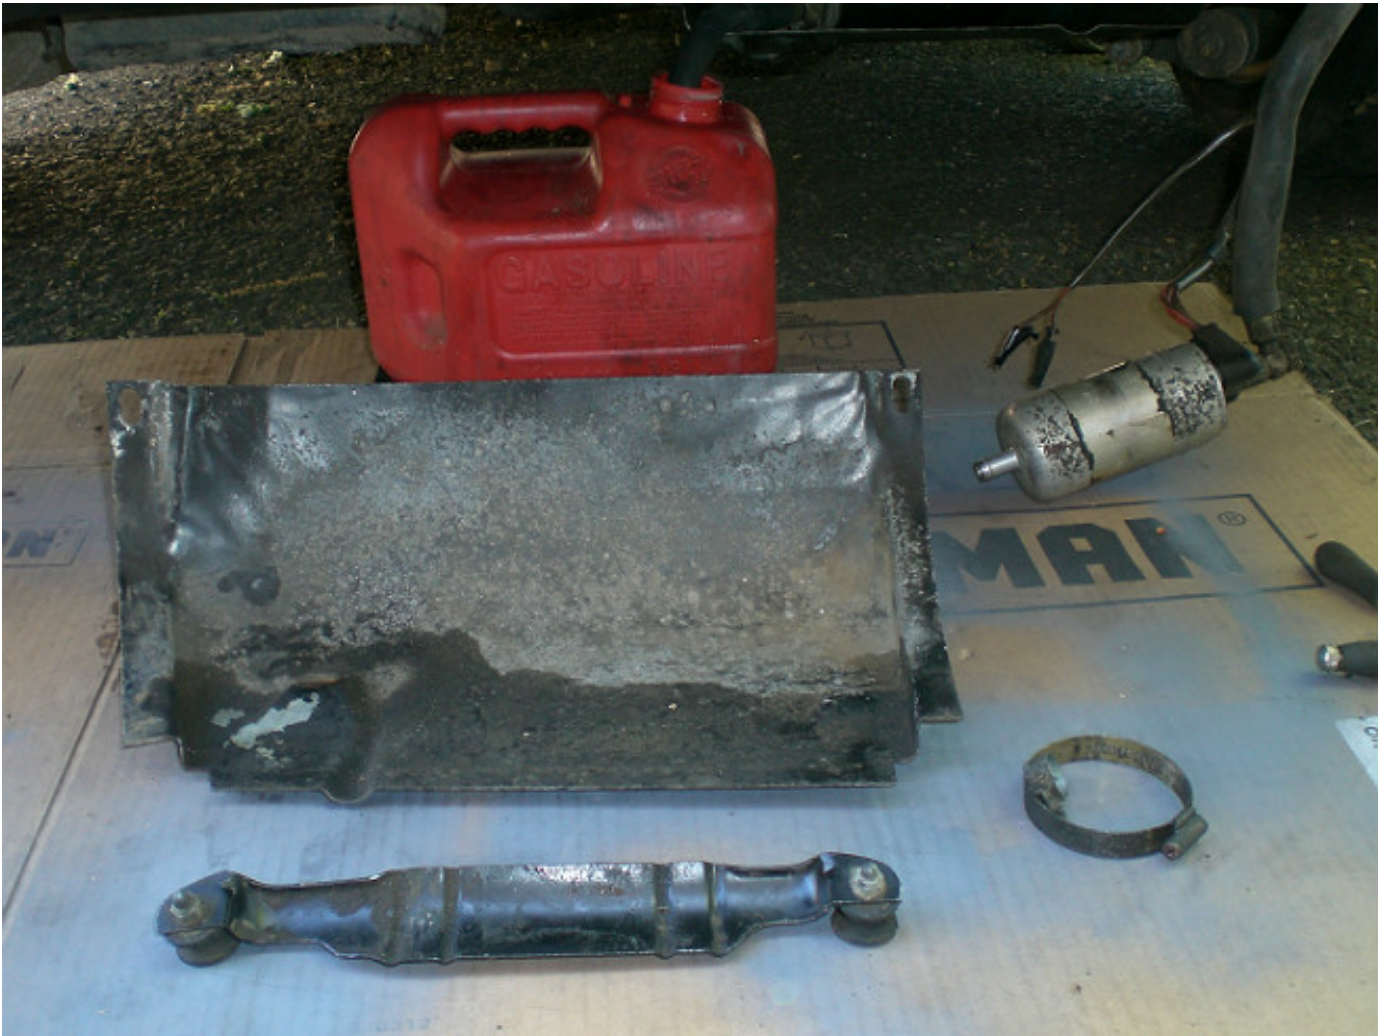
I saw the fuel pump clamped to its cradle but no rubber isolators there to suspend the poor thing onto the cover — it was literally thrown in there. Right, then two stray wires began to poke their way from behind the pump with the ends wrapped in black

electrical tape. It didn't occur to me then that she had a second fuel pump screwed into the tank with two naked electrical prongs missing their mates. I've yet to understand the logic behind this move.

With the fuel pump cover off, we begin to see the reality of what sort of project this is going to be. Fuel pump on upper right with two wires taped off that should have been connected to the in-tank fuel pump. Below is the fuel pump cradle with broken rubber isolators.

Not only did the pumps look original, but the fuel hose I was about to detach looked like it was about to disintegrate the moment I breathed on it. I kept the fire extinguisher and tons of rags within arm's reach. As I carefully separated the hose from the pump and drain the tank, I thought about the \$500 or so I'd have to spend right here for two pumps and a fuel hose. And I hadn't even dropped the tank yet.

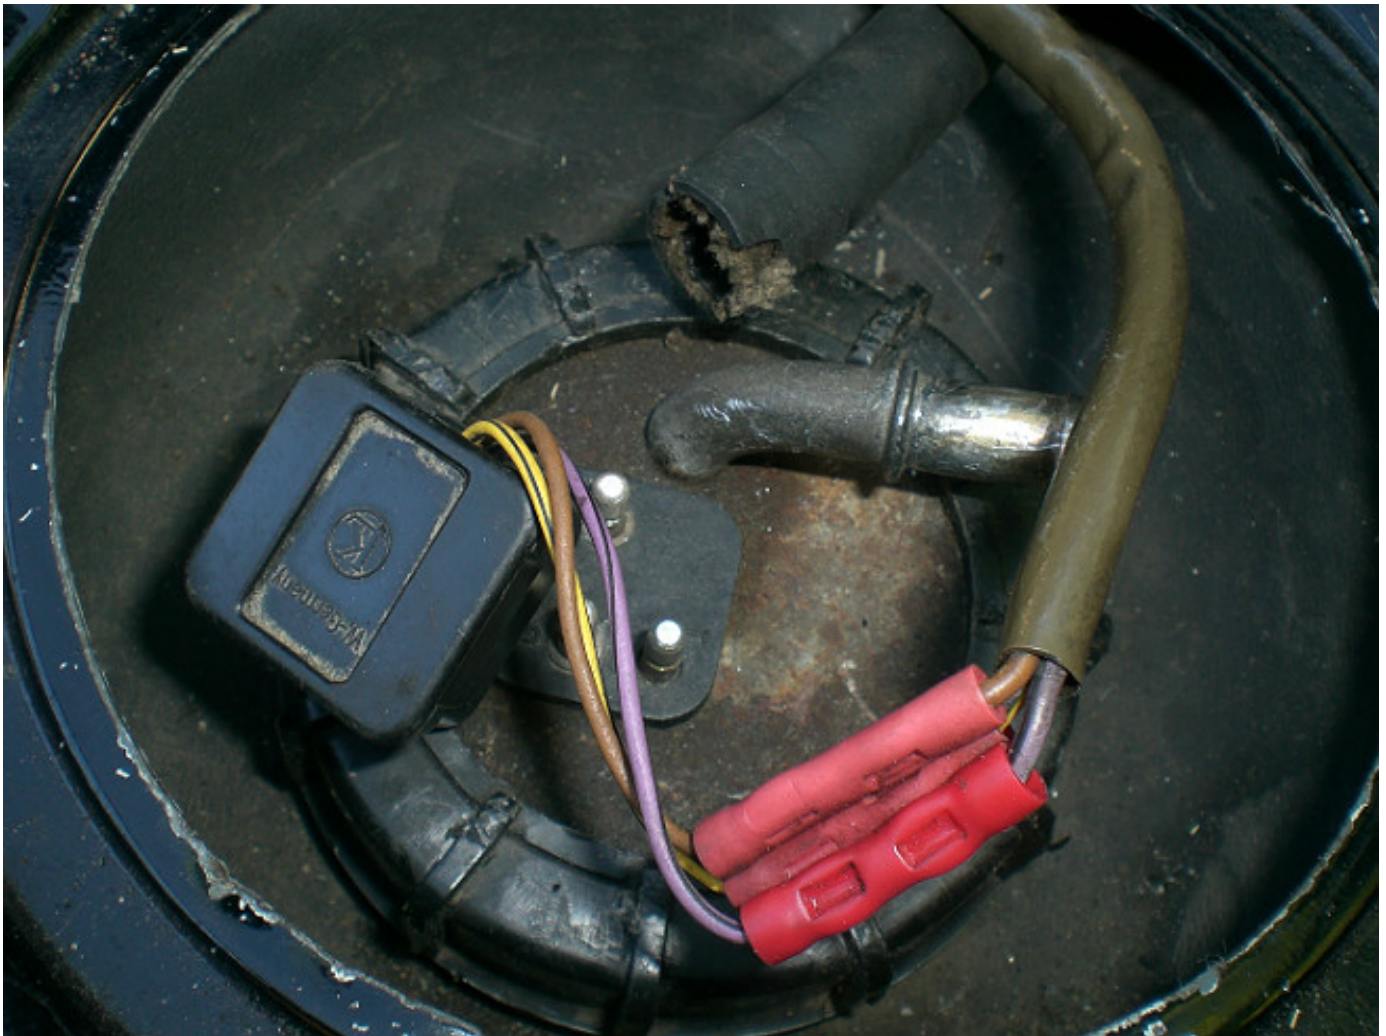
Moving on into the trunk, I unplugged the hacked-up and spliced-together fuel level sending unit connection and removed the fuel return line hose that looked like a party favor with frayed nylon ends and shredded rubber casing.

This sort of careless attention to detail is a pretty common site on cheap, older Porsches. Here is how a wiring issue was addressed on the fuel sender unit plug. Notice the frayed fuel return line on the upper right.

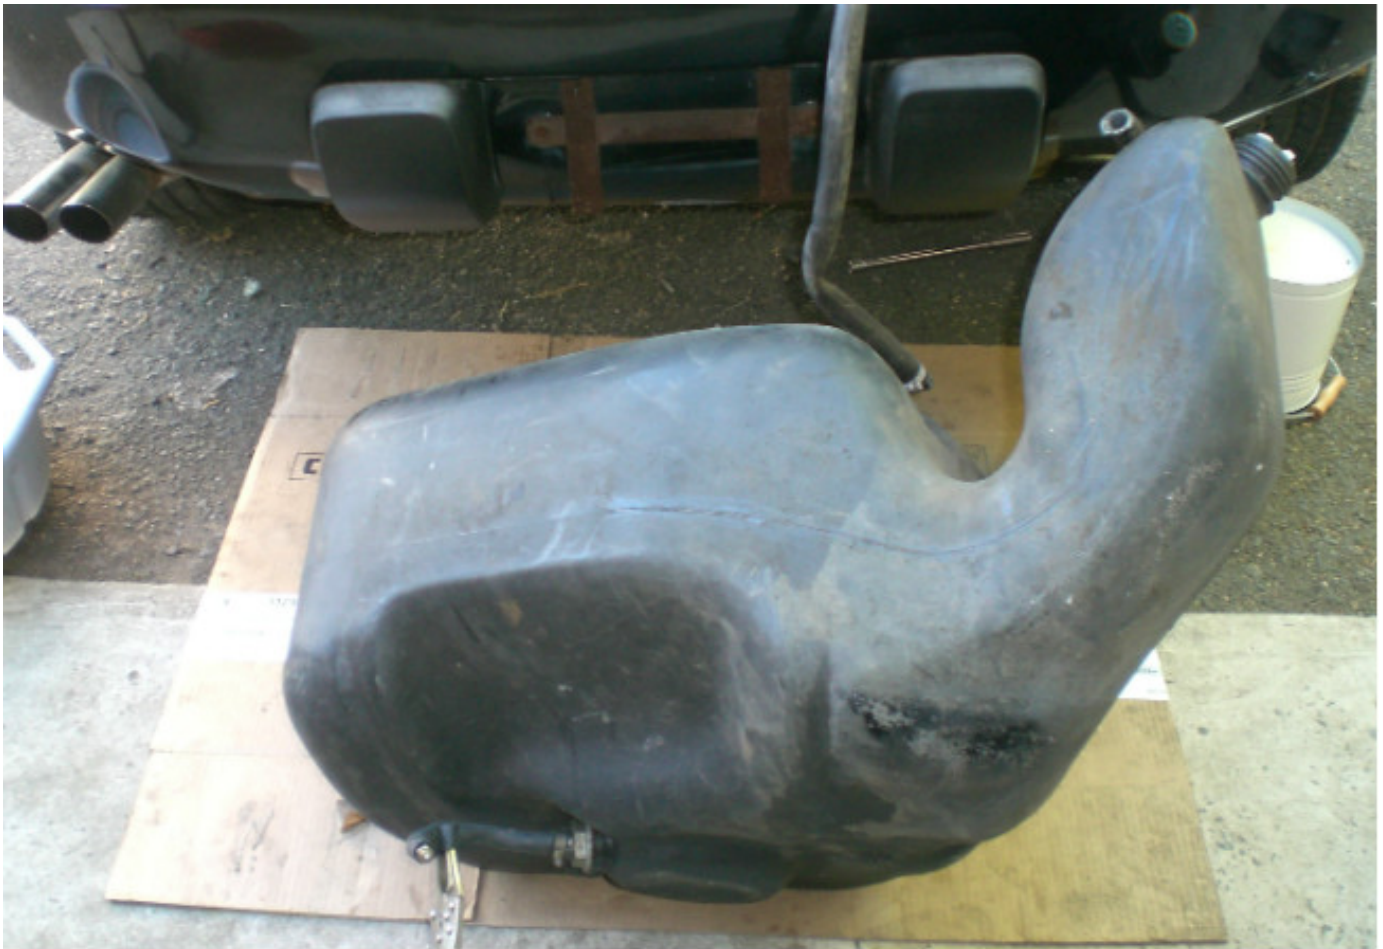
Then, after detaching the filler neck grommet, separating the vent hoses and undoing the four bolts on the cradle that hold the tank to the chassis, she came down after some finessing. As I inspected the tank, I discovered a few stress cracks where the tank cradle held it that caused the mysterious leakage. These amounted to what the previous owner described as a "pinhole leak."

The "ostrich" as it's known in Porsche tech parlance. Cracked fuel tanks seem to plague lots of these early 928s, so be aware of this should you be in the market for one.

Now, I could buy a used one for about \$450, but I rolled the dice and tried my hand with a plastic welding kit to mend it. It wasn't too difficult to see that we're potentially into this project for about a grand. It was a lot to take in following an afternoon's worth of work, but I expected this sort of outcome anyway.
